AFOSR-TR-78-0407

THE STRUCTURAL CHARACTERISTICS OF RADIATION DAMAGE
PRODUCED BY HIGH ENERGY (2.7 MeV) ION IMPLANTATION IN GaAs

G. H. Narayanan and W. G. Spitzer
Department of Materials Science
University of Southern California
Los Angeles, California 90007

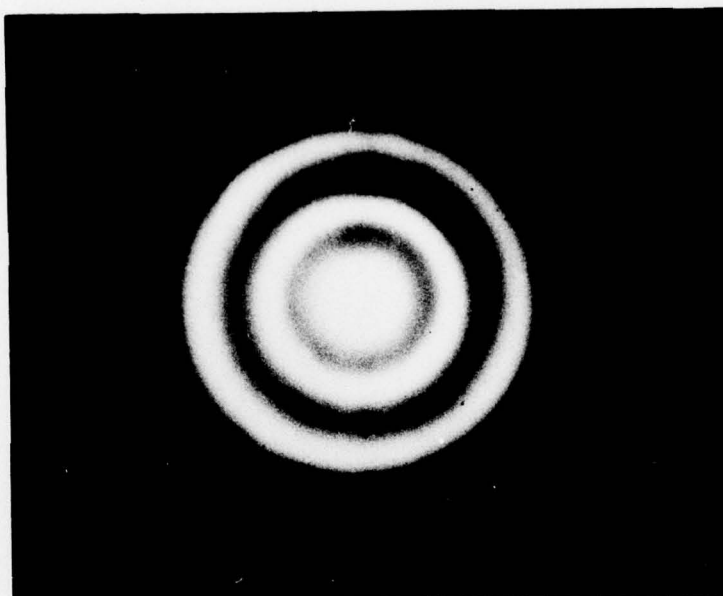
- Figure 1 (a) A Transmission Electron Diffraction obtained from the heavily damaged region $\sim 2\mu$ below the surface of a 2.7 MeV P^+ implanted GaAs specimen.

Figure 1(a) shows a typical electron diffraction pattern obtained from the heavily damaged region of a GaAs specimen implanted with $^{31}\text{P}^+$ ions having an incident energy of 2.7 MeV and a total dose of $6.4 \times 10^{16} \text{ ions/cm}^2$. This heavily damaged region, occurs at a depth of 2μ below the original surface which roughly corresponds to the position of the peak in the depth distribution of the implanted species in the specimen. The pattern in Fig. 1(a) is composed of three diffused rings

or halos surrounding the central spot, and is characteristic of those produced by amorphous films. Thus it is quite evident that implantation of high energy P^+ ions in large doses has driven GaAs in this region into an amorphous state.

The electron transparent region of the specimen had a wedge-shaped profile as illustrated in Figure 1(b). The diffraction pattern shown in Figure 1(a) was obtained from the thinnest regions of the foil, which consisted only of the amorphous layer. The patterns taken from the adjacent thicker areas of the foil revealed, in addition, the presence of diffraction spots arising from crystalline GaAs which were superimposed on the diffused rings from the amorphous layer. An example is shown in Figure 1(c). It can be noticed that the strong diffraction spots are also circled by diffused rings. This is clearly a double diffraction effect whereby the strong diffracted beams originating from the crystalline region act as new sources for further diffraction from the amorphous region. Since in the present study all the specimens were examined in the microscope with the implanted side facing the incident electron beam, the above observation clearly implies that overlaying the amorphous region there exists a relatively less damaged crystalline layer.

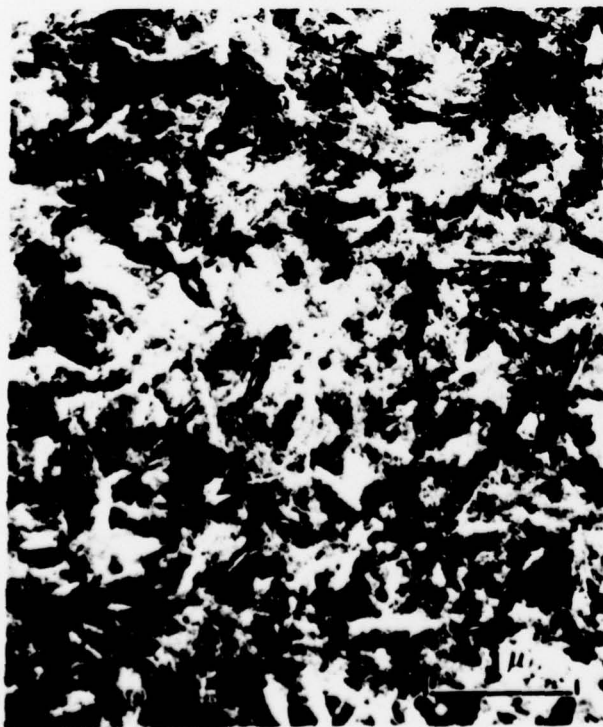
b

- (b) Brightfield micrograph corresponding to Figure 4(a) showing the morphology of the recrystallized polycrystalline layer.
- (c) A Dark-field micrograph obtained by imaging a segment of the bright diffraction ring in Figure 4(a) showing shape of the individual crystallites.

The annealing at 250°C for 6 hours was found to cause the recrystallization of both the buried amorphous and crystalline layers. The recrystallized polycrystalline layer, thus, extended from the original amorphous layer substrate interface clearly to the surface, thereby eliminating the prior distinction between the cover and buried layers.
